# Russell Inspection Services

## Septic System Evaluation

Property address: 123 Main St. Anytown NH

Eval. Date: 4/21/2012

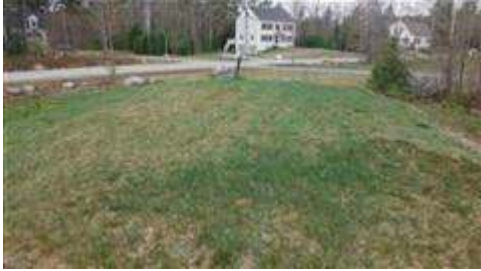
View of the EDA

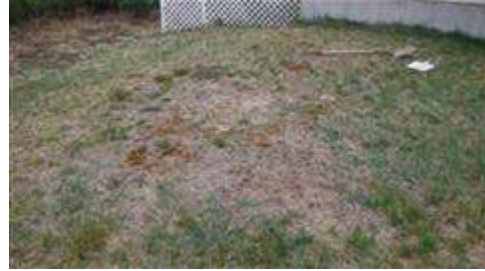
Treatment tank location

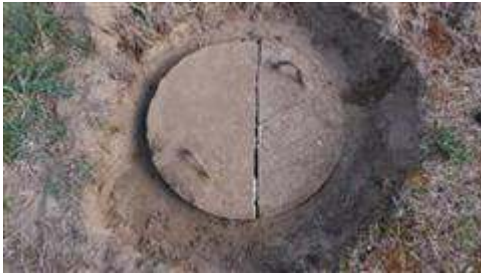
Cracked cover, 23''

1. Treatment tank should be pump as soon as possible and subsequently every two years thereafter.
2. Replace cracked treatment tank cover.
3. Install new effluent filter in outlet baffle.
4. Maintain system and be aware of daily water consumption and usage.  
(Normal recommendation for any system)

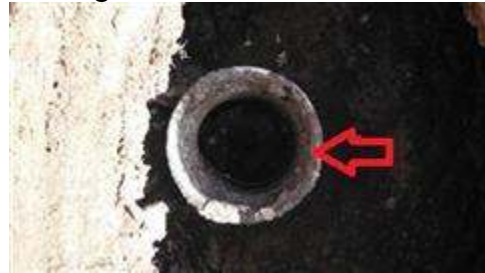
Filter: In tank: Missing

Missing effluent filter

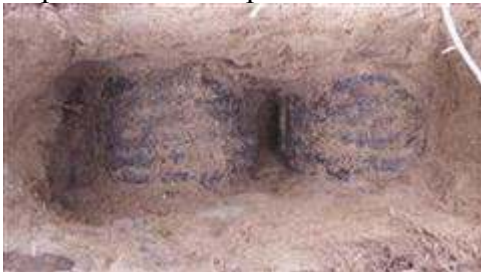
Inspection hole #1 pre load test

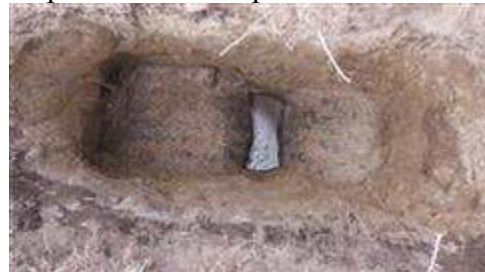
Inspection hole #2 post load test

Effluent has risen 1/3 up from the bottom of the lateral.

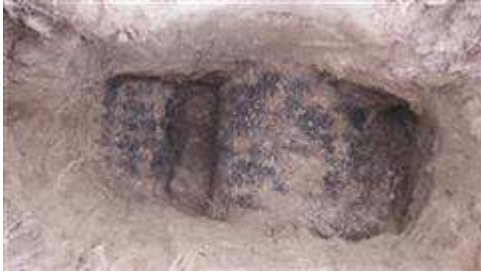
Inspection hole #2, remained dry

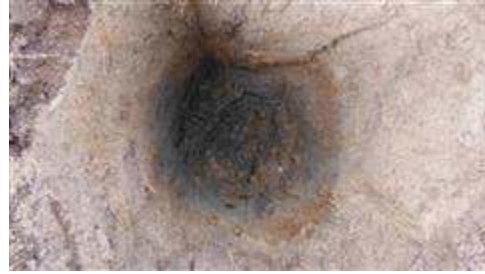
Inspection hole #3, note staining

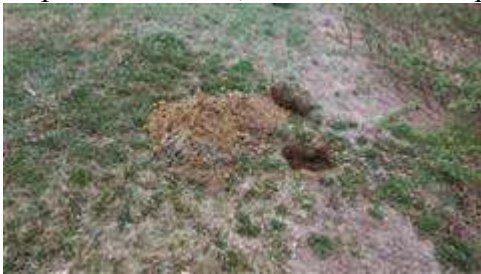
Inspection hole #3, on downward slope

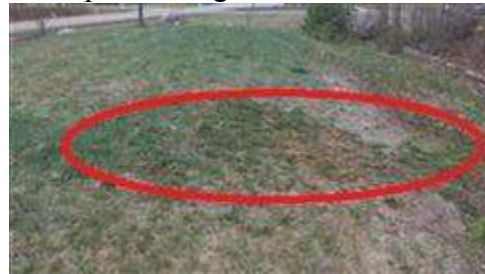
Absorption is higher in this area

The last four images were taken to the right of inspection hole # 1, which is at the beginning of the EDA and directly in front of the treatment tank. Higher absorption at the beginning of a serial system is common.

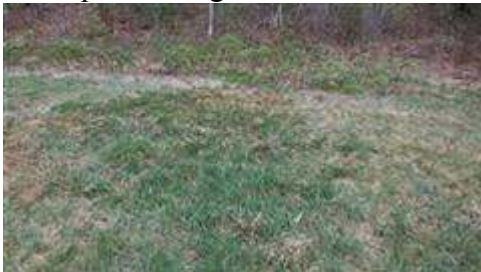
Absorption is higher in this area

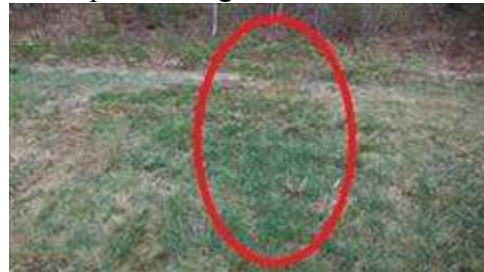
Absorption is higher in this area
