Russell Inspection Services

Septic Report

123 Main Street
Anytown NH 12345

John Smith
123 Main ST
Anytown NH 12345
youradress@xxx.com
Eval Date: 5/11/2012

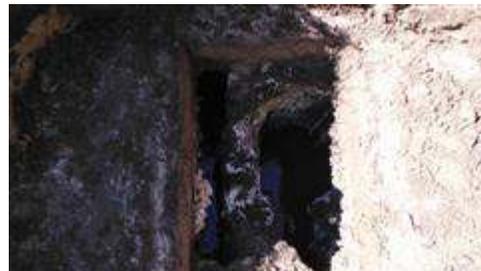
Outlet Baffle: Concrete Condition: Good

Outlet baffle

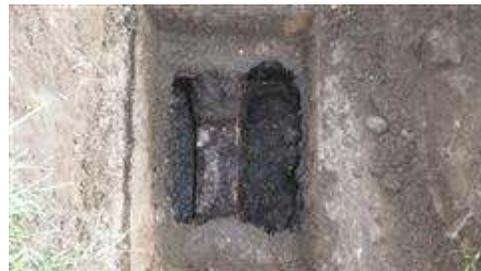
Inlet Baffle: Concrete Condition: Good

Inlet baffle

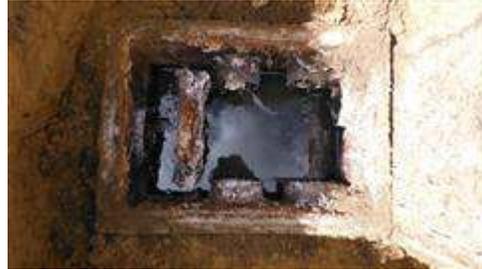
D-Box. Note deteriorated baffle

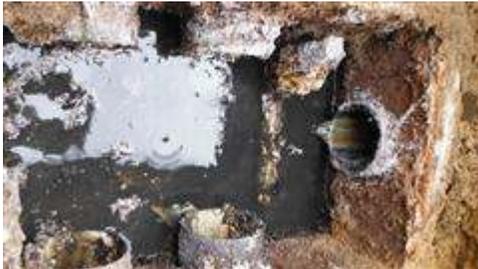
Deteriorated baffle in D-Box

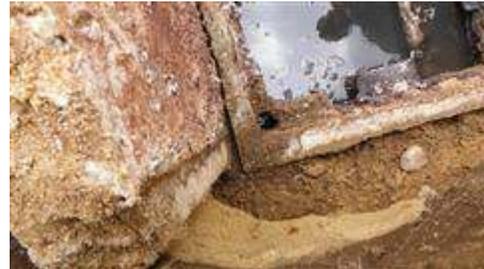
Small crack in D-Box

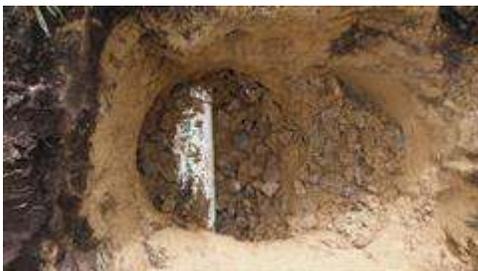
Inspection hole #1, clean material

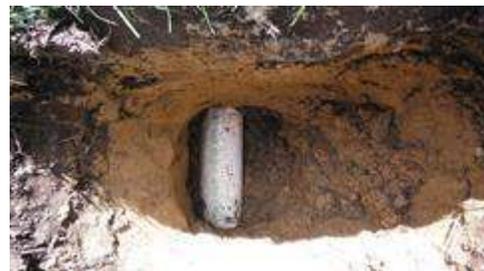
Inspection hole #2, clean material

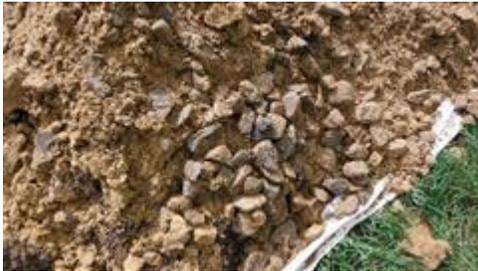
Clean material removed from
inspection holes
